Hippos (Sussita) 2016 – 17th Season Daily Log and Drawing

Date: 19 July 2016_____ Area: NIP Manager: Schuler

Squares	DO45	DN46	DR45		
Loci	2155	2155			
Baskets	3471	none	none		
Walls	541, 2153, 2156				
Floors

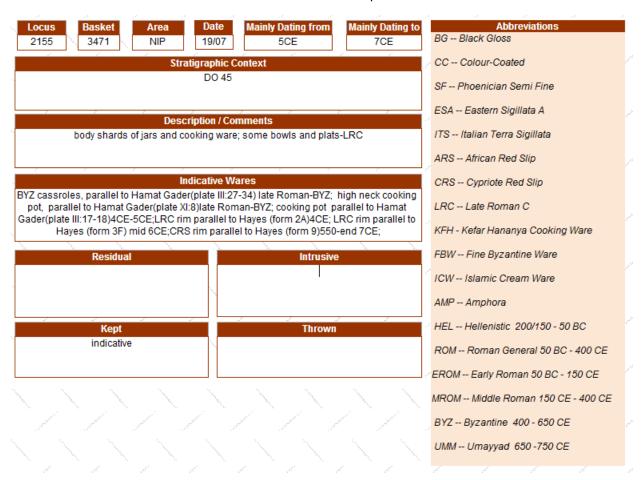
- i. Mostly destruction fill
- ii. Removed a short remaining section of floating W541.
- iii. Some pottery (mixed)
- iv. One small nail of 7 cm was recovered (#857).
- v. Minimal indication of W2156 at this point.

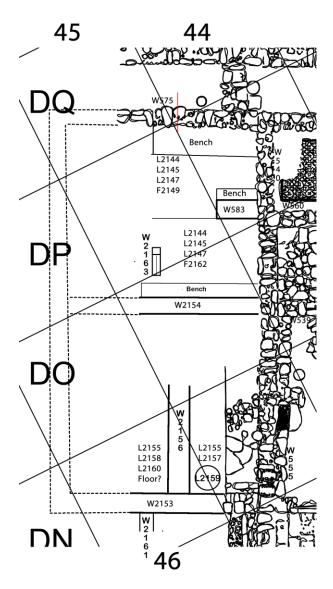
- i. Exposed a roughly 1 x 1 m section of the top of the previously identified tank.
- ii. The rim of the tank is topped by reused marble slabs. The slabs are some 20 cm wide on the west, 24 cm on the south and 13 cm wide on the east.
- iii. Most of the slabs are plain white
- iv. The central slab on the south rim has a three-leafed plant (?) inscribed into it with a seed/bulb under the plant
- v. Two 24 cm slabs on the west rim are decorated.

- 1. One has three ficus leaves with a border on each side alternating between pointed ovoids and two triangles top to top (hourglass).
- 2. The other has a central vine with a border of nodules on either side.
