Northeast Insula Project

Antiochia Hippos

Preliminary Report of the 2016 Season

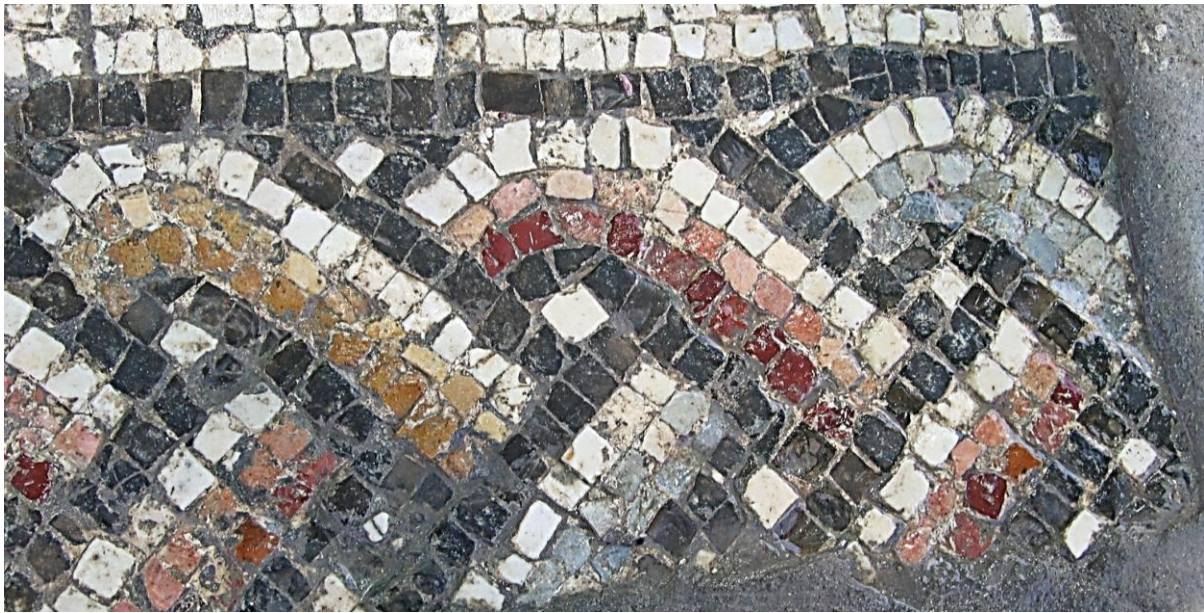
First layer of the mosaic carpet in the *domus*.

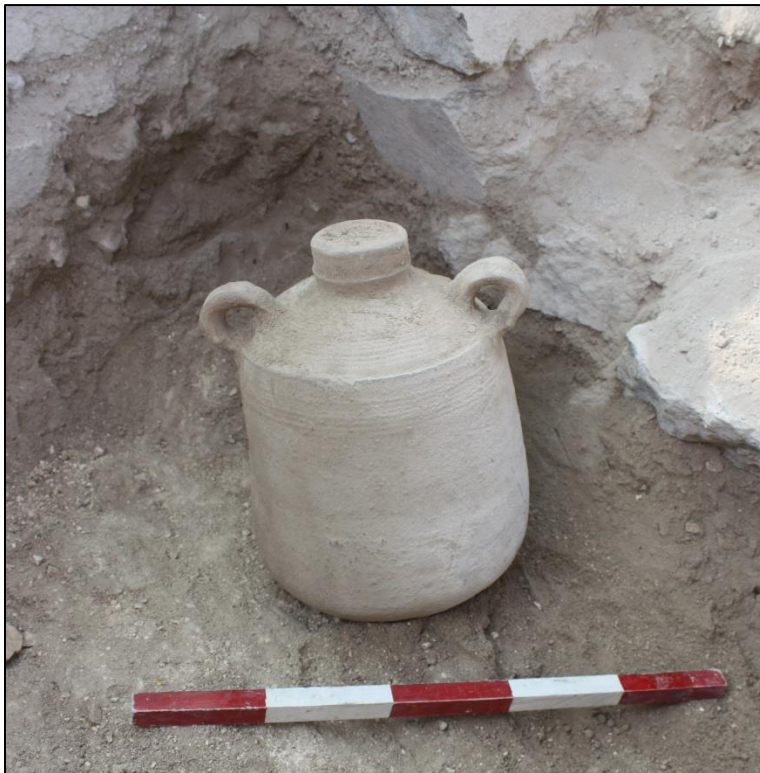
We postulate that the area was used primarily for storage. The ceramic assemblage included storage jars and cooking pots (5-6 CE), and the notable find of a fully intact small storage jar.⁴

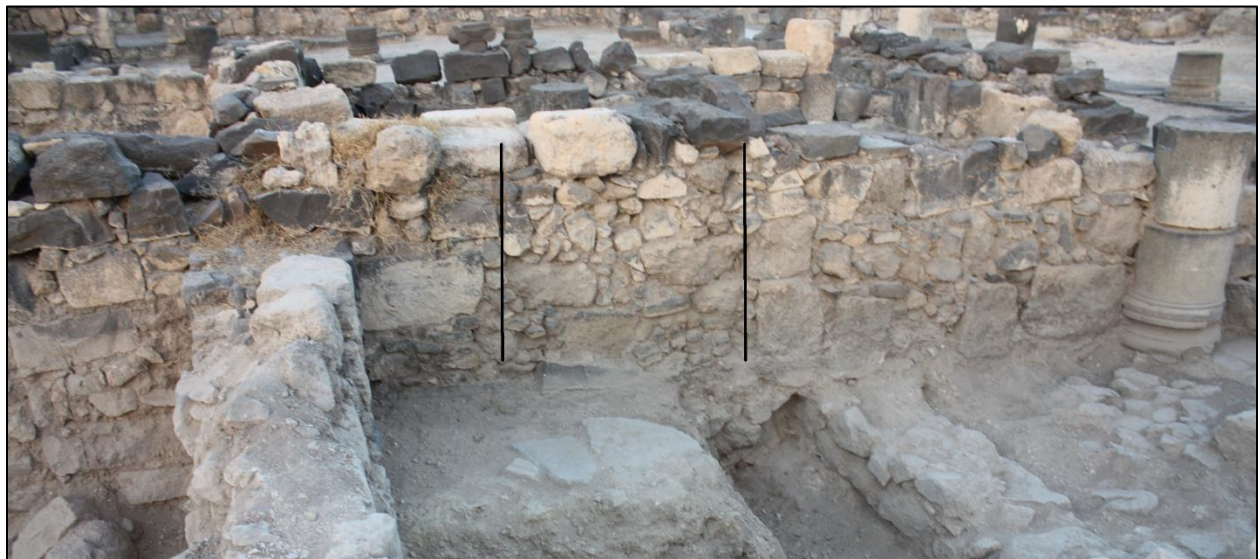
The doorway begins 60 cm from the corner and is 140 cm wide. This blockage in W540 along with the addition of a course of stones (W555) on the south face of W540 sealed off the Northern Building while allowing continued (domestic?) use of the North Lateral and Medial Chambers after the complex and the *domus* were decommissioned.

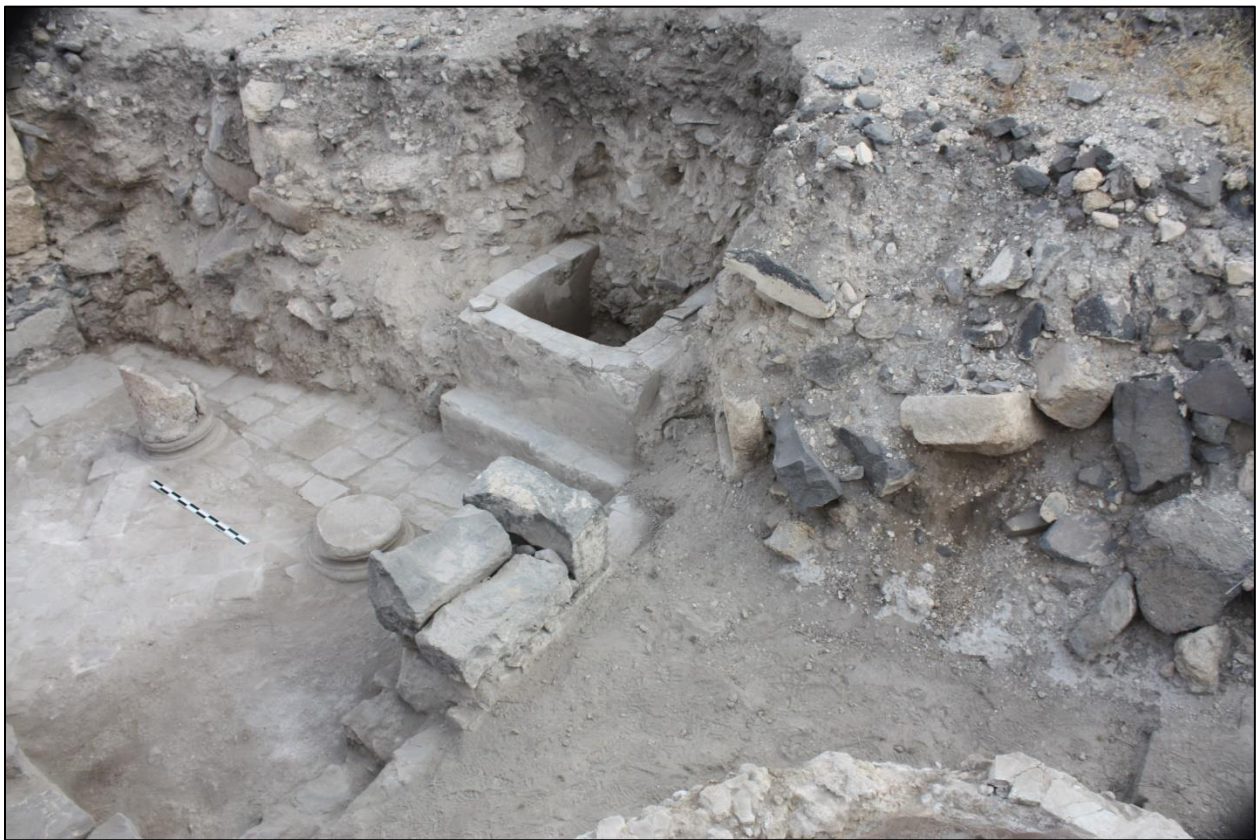
Additional exposure of a Water Feature

While cleaning up the northerly courtyard/garden of the House of Tyche, we exposed a bit more fully a second water feature north of the lower section of the courtyard. The first ledge is 33 cm above the floor and is 16 cm wide. The top of the water feature is 54 cm above the ledge. The feature is 143 cm wide from east to west. The interior measurement is 97 cm. The top ledge is surfaced with reused marble slabs 20-30 cm wide, some of which are decorated with ficus leaves. Inside the feature there is a ledge on the south and west sides of the feature 93 cm below the top ledge, with the bottom of the feature another 19 cm below. We sifted material from the water feature, recovering only small ceramic

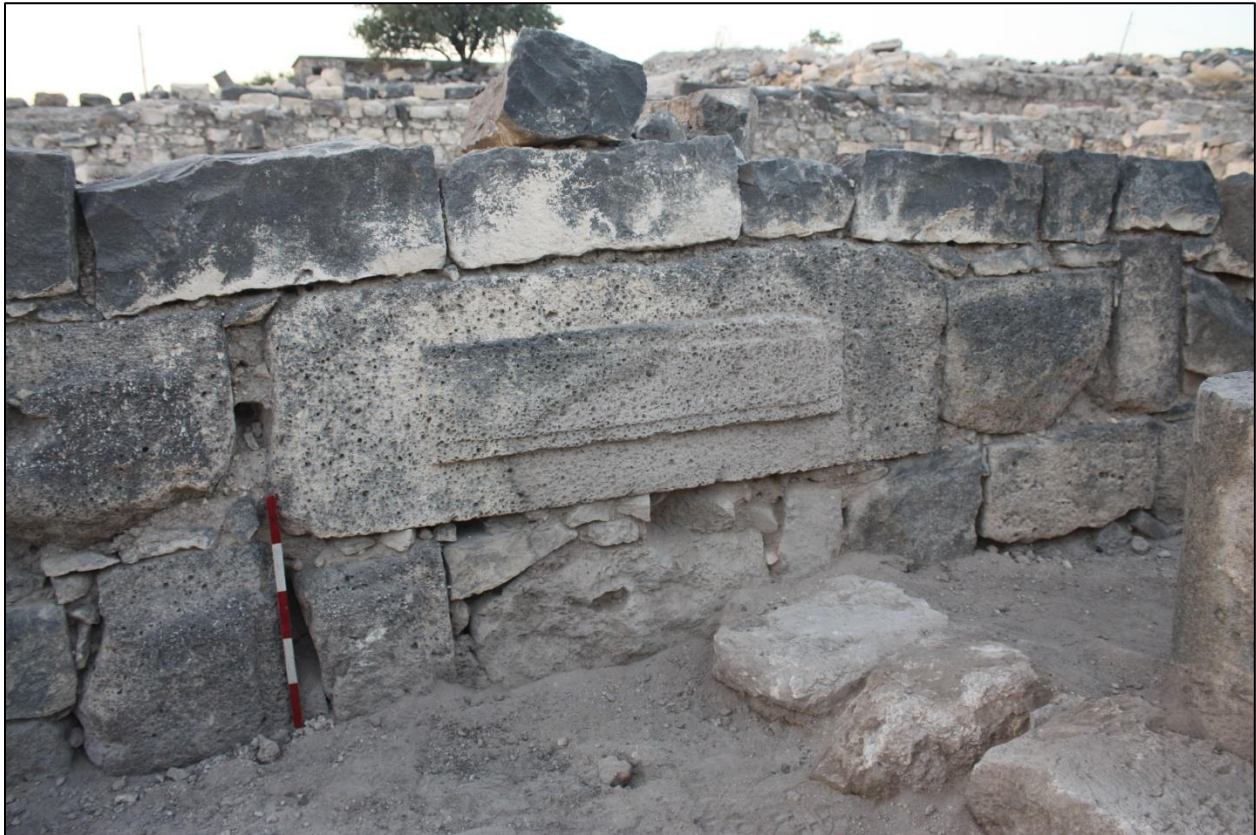
An Early Entrance to the House of Tyche

After removing a blockage in Cardo 3N between W575 and the House of Tyche to the east, we revealed the top of a blocked doorway in the west wall of the house. The lintel stone (161x52 cm) is *in situ* and has double incising, the first being 30 cm and the inner incising is 5 cm. The depth of each incising is 2.5 cm. The lintel stone is flanked on each side by 60 cm stone with 8 cm incising. The door jambs are 25 cm wide. The doorway is 110 cm. There is an incised stone to the north of the north door jamb. Using the height of the doorway to the courtyard/garden as a comparison, the threshold for this doorway would sit at the approximate level of the black and white paving of the lower (western) covered courtyard. The current steps and drainage channel from the peristyle court are about 50 cm above that level. This dramatic doorway is likely remains of the first phase of the House of Tyche.

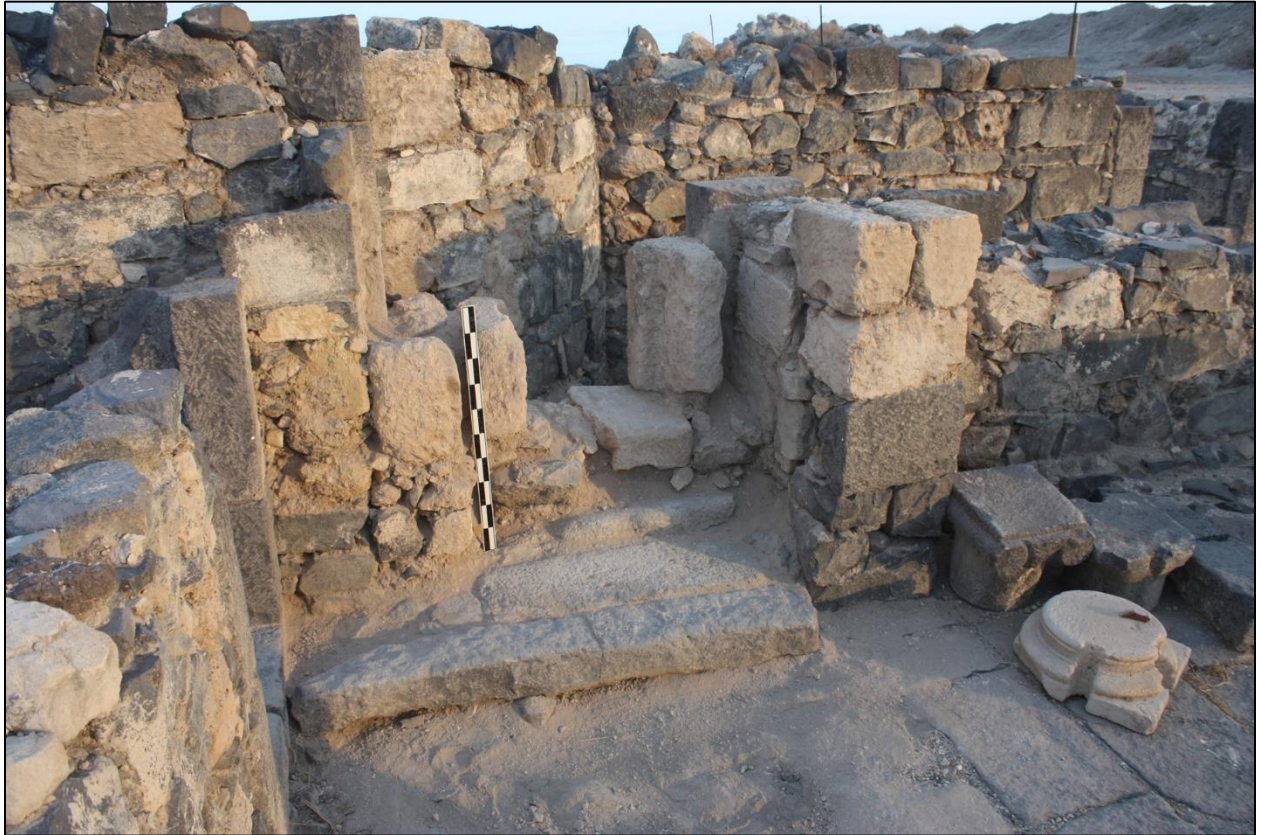
Conservation of a connecting doorway

Finally, we note the repair and conservation of the doorway between Cardo 3N and the west wall of the House of Tyche next to the apse of the church. The reconstruction was done by the conservation team onsite and worked to match as closely as possible the photographs of the doorway when it was first exposed. The conservation preserves a key piece of evidence for the hypothesis that the interconnected structures in the Northeast Insula may in their last phase have been an urban monastery.
