Hippes 02 NEC
 CEC corner
 17 July 02

Hippos 02
SEC
L 506
22 July

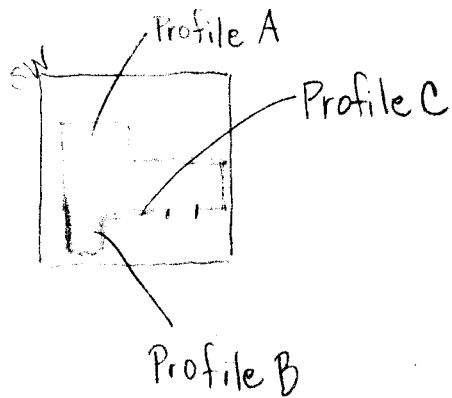
C. Exterior wall West side of church
