Hippos (Sussita) Excavations 2003 – 4th Season

Daily Log + Drawing

Date: 6 July 2003 Area: NEC Manager: Schuler

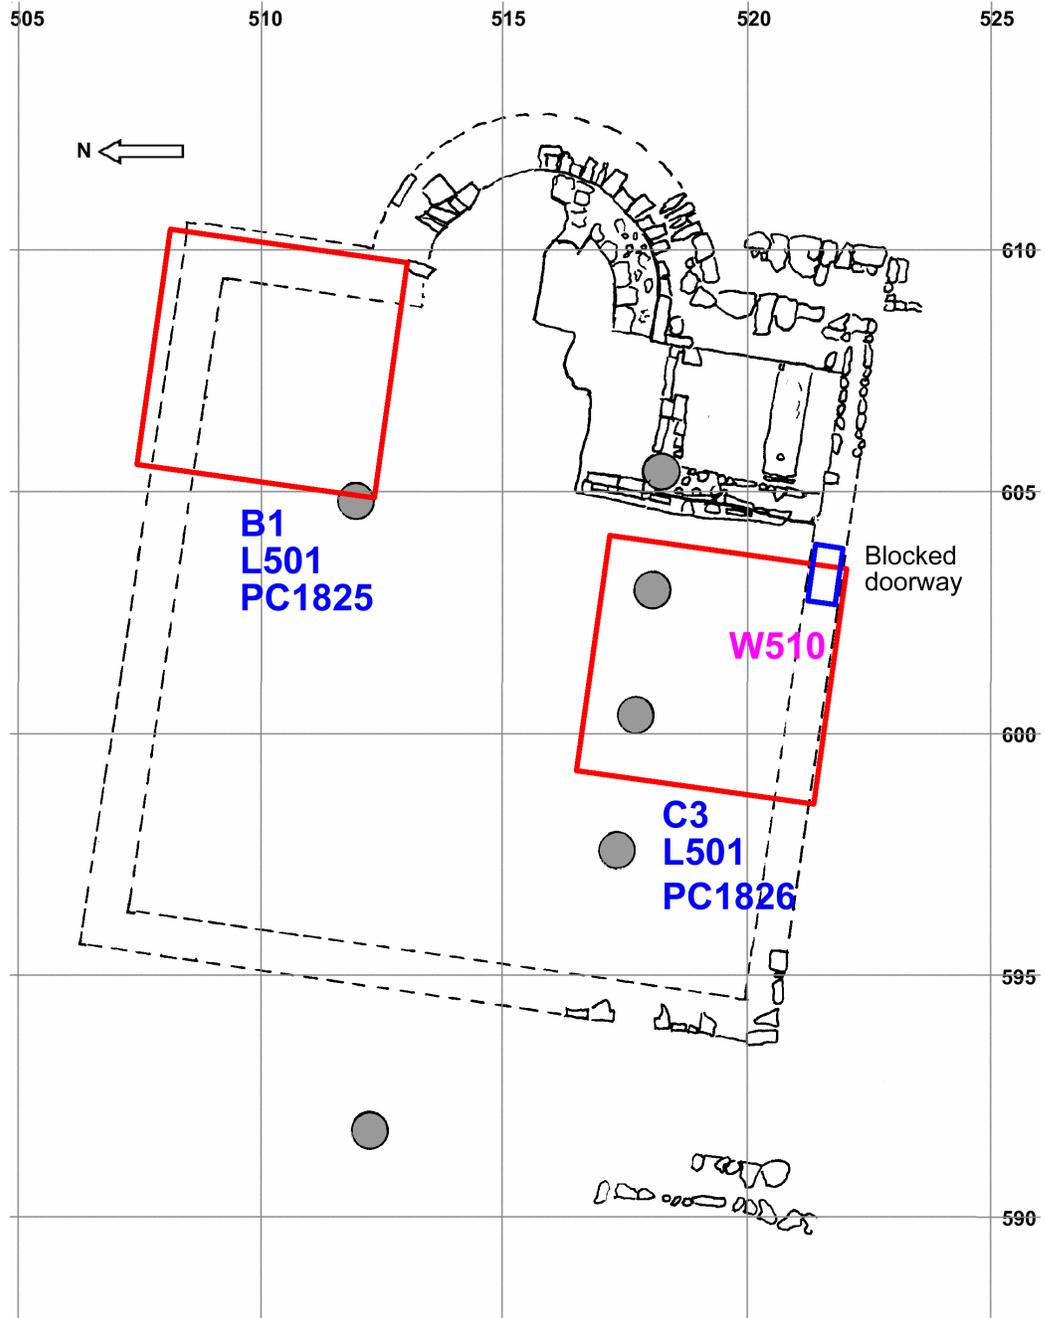
Daily drawing 6 July

- Removed destruction debris from inside of church walls. The exact line of the walls on the NE corner is unclear
- Several doorjambs were in the debris. There were also wedged pieces worked in several sides (evidence of arches).
- Opened Square C3
 - Starting elevation = 132.0
 - Ending elevation = 131.48
 - Soil is Horizon A and some Horizon B
 - List of AI items
 - 028 rectangular piece (36x65) with notched corner

-
- A doorway (new Locus 519) on the south wall just west of the chancel screen was partially uncovered. The doorway has been stopped (secondary remodeling of church?). The original doorway was closed from outside the church, suggesting that there is a room to the south.
