Hippos (Sussita) Excavations 2003 – 4th Season Daily Log + Drawing

| Date: | 30 July | 2003 | Area: | NEC | Manager: | Schuler |

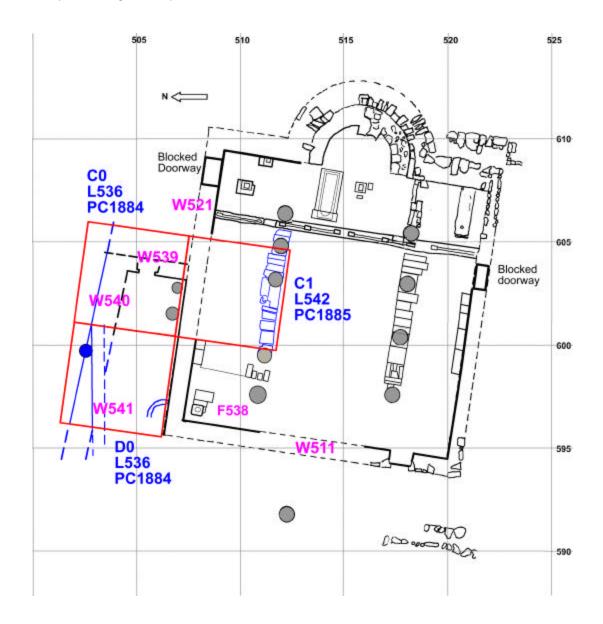
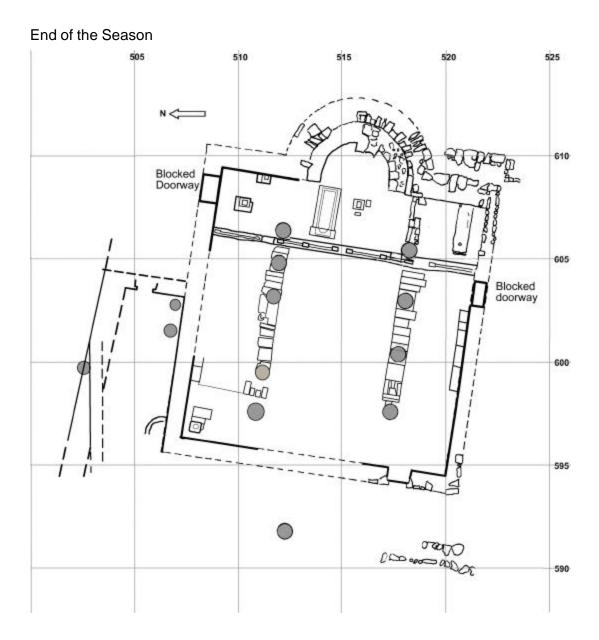
Daily Drawing 30 July

- W540 seem to move slightly north as it proceeds west. At W539 its exterior is 4.1m from W521. At the NW corner of the church, the exterior of W540 is 4.65m away.

- At 4.94m from the junction with W539 a column base/drum (diameter. 52) in situ protrudes partially for the exterior wall line.
 The column has been incorporated into the wall.

- At the intersection of the N/S line of the exterior of W511 with W540, two column drums on their sides (laying north/south) seem to form a corner. Further excavation will clarify.

- 3.65m from the junction of W539 and W540, a wall (W541) that overlays W540 veers slightly to the WSW (1.1m south at the exterior line of W511). It may continue to the west.

- Whether W511 continues north of W521 is unclear at this stage.
 A small basin installation (3/4 circle) at the seeming continuance of W511 north of W521 is suggestive. But the basin aligns a bit too far west. W541 and the basin may be indicative of later agricultural use of the ruins of the NE church

- Continued work in Square C1
 - Starting elevation = 130.93
 - o Ending elevation = 130.68
 - o Soil is Horizon B
 - o PC1885 will be analyzed in 2004.
 - Exposed the complete run of the stylobate and five column bases. CN1-4 are on the stylobate. CN5 sits on a plaster base.

- The column bases in the north run are most irregular. All five are significantly different in profile and elevation
 - Elevation
 - CN1-131.45
 - CN2-131.55

- CN3-131.13
 - CN4-131.07
 - CN5-131.04
 - Although CN1 parallels CS1, the gaps between columns in the north aisle are shorter:1.76-1.8 between each except CN3 and CN4 where the gap is double (3.55) Perhaps a column base is missing.

The south aisle displays a consistent run of four column bases evenly space. The north aisle may have a run of six column bases covering the same distance. Either this inconsistency display poor construction, a later and major repair/rebuilding, or a feature in square C1 yet to be revealed that requires a gap between CN3 and CN4.
