Hippos (Sussita) Excavations 2004 – 5th Season Daily Log + Drawing

Date: 6 Oct Area: NEC Manager: Schuler

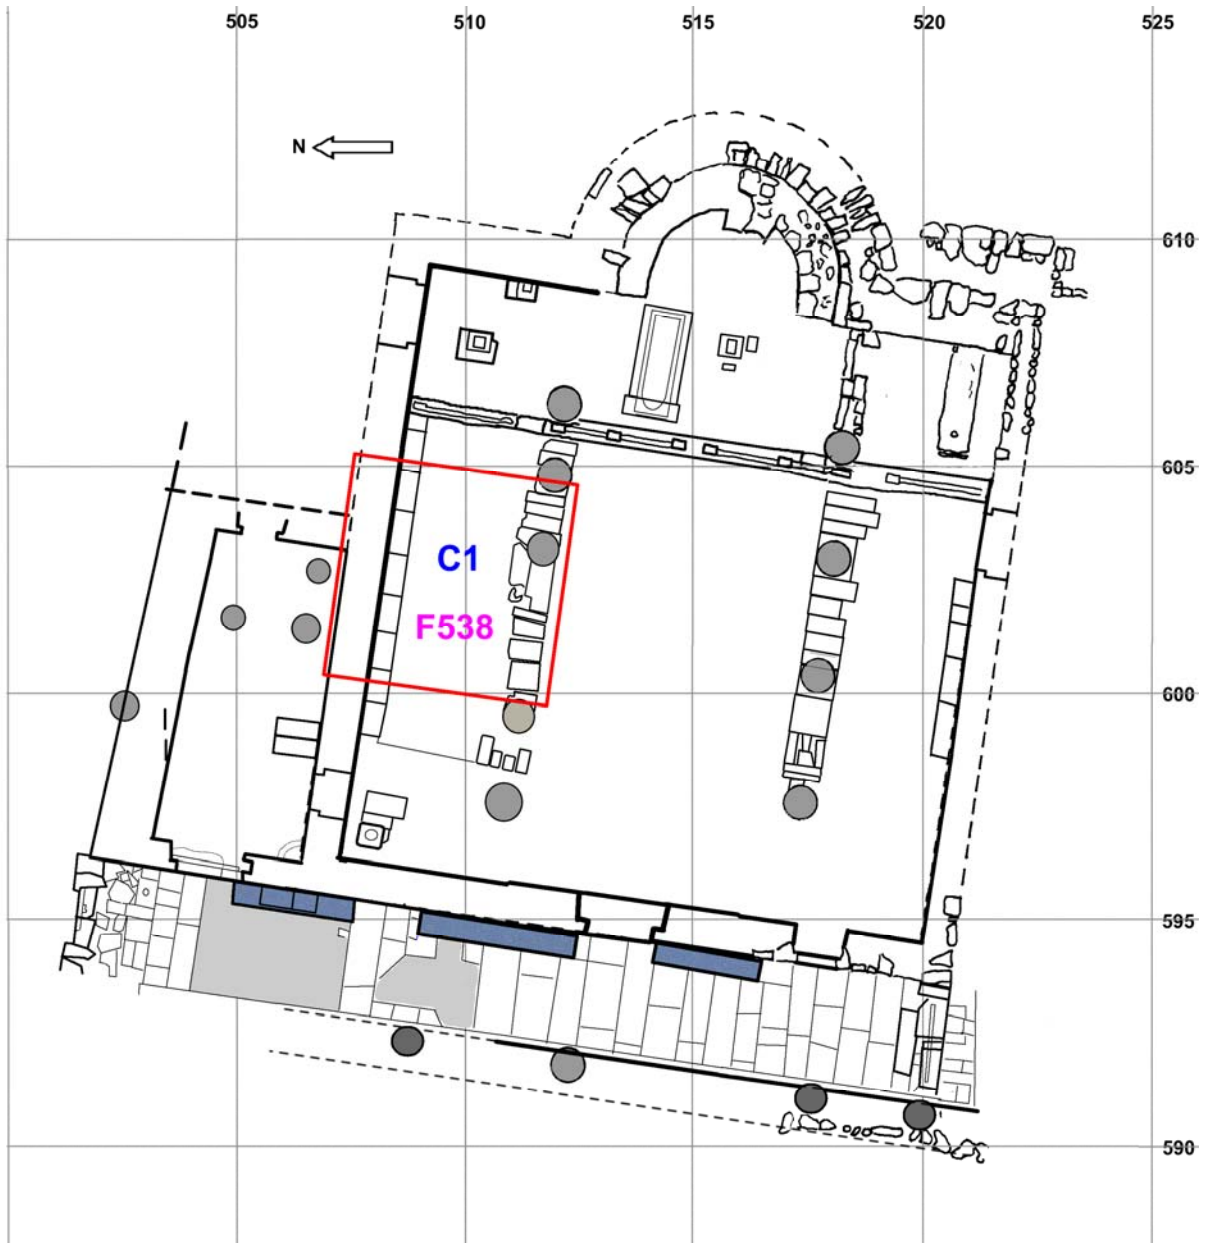
Daily Drawing

- Continued work in Square C1
 - Cleaned mosaic surface of fragments of floor F538.
 - Revealed four red crosses next to base of chancel screen
 - A guilloche pattern identical to that in the south aisle ran parallel with the stylobate.
