Hippos (Sussita) Excavations 2007 – 8th Season Daily Log + Drawing

Date: 19 July 07 Area: NEC Manager: Schuler

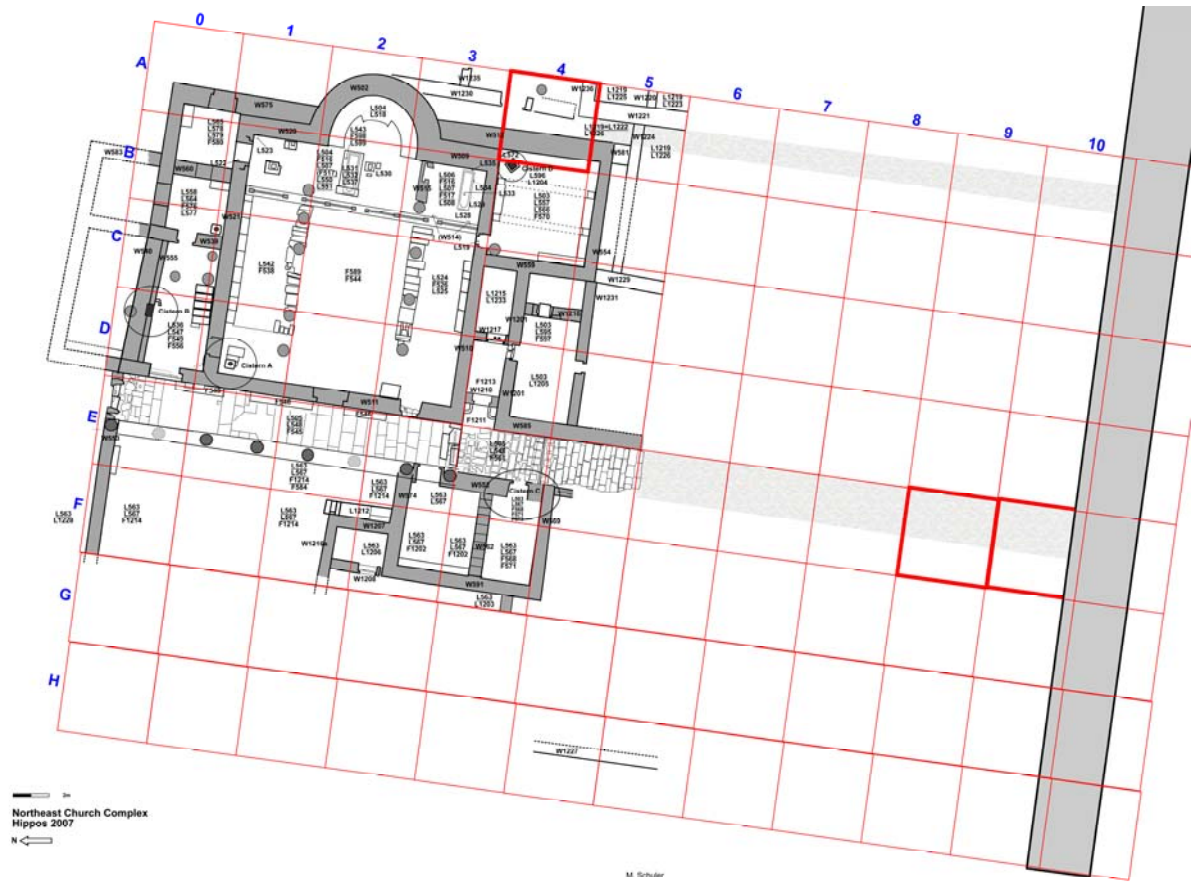
Daily Drawing

- Ending elevation = low street = 132.179; high street = 132.423; W1230 = 132.585
 - Soil is Horizon B.
 - Excavated primarily the area of the cardo.
 - Discovered the second door jamb for W1230 at 90 cm to the south. However the jamb is tipped somewhat to the north. Lower courses will give proper alignment.

- As W1230 proceed south it drifts to the west. At its southerly end it is 30 cm further west than the corner of W1221 and W1236 at about .5 m north of the same corner.

- The south east section of the square is still undefined and awaits excavation.
- Continued work in E6-7
 - Cleaned walls and swept floor for details.
 - Paved are laid up against wall stones, suggesting that the paving was later than the walls.

- Ending elevation = paver north = 129.362; paver middle = 129.062; level upper south area = 129.055
- Significant collapse is evident on both sides of the street. To the east, only one course of the wall remains. To the west, many ashlar are tipped over into the street. A number of pavers have been robbed out.
- We succeeded in removing most of the fill. We await removal of large pieces from the area with the tractor.
- Some additional removal of collapse necessary on the west side of the street.
