## Hippos (Sussita) Excavations 2010 – 11th Season Daily Log + Drawing

Date: <u>26 July 10</u> Area: <u>NEC</u> Manager: <u>Schuler</u>

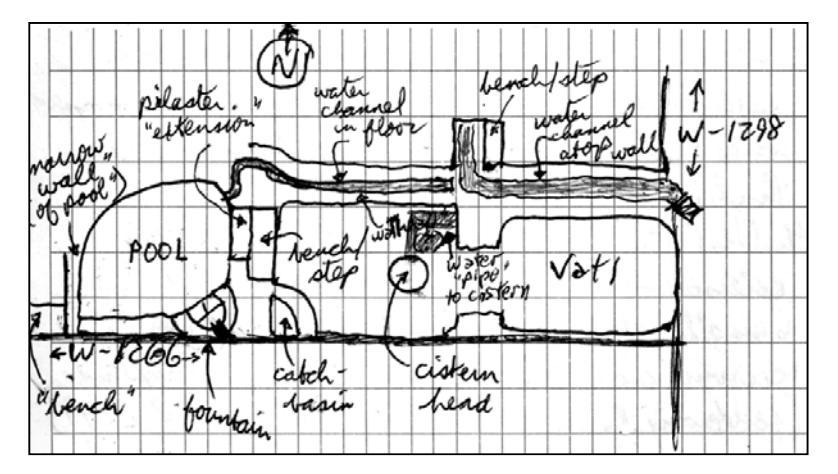
- A 60 cm pilaster extends the line of W1910 to the north of W1266. It is then extended on the west by a 30x90cm stone, plastered on the west face and forming the east wall of the adjacent pool. On the east side is a 30cm step and another 26cm step below.

- To the east of the above fixture is a catch basin. The floor (F1919) in this area (east of the fixture, south of the channel and west of the vat) is of poor quality (plaster mixed with mud). Its elevation is even with the third step and may suggest that an earlier floor is below.

- To the west of the above fixture is a pool (L1918). The fountain is in the southeast corner. The pool is 1.67x1.67m (interior dimension). The south and east faces follow the line of walls. The west face curves into the north face in a somewhat irregular arch ("d" like). The wall of the pool is 25cm thick on the west and north. A 20cm wall abuts W1266. To the west and 54cm below the top of the pool is a 25cm "step" paved with stones (some marble reused) set in plaster. The design is similar to the design of the water basin in the north balk. Part of the northwest wall of the pool has been damaged by destruction fill.

- o Soil is Horizon C
  - Work in L1907 was suspended so that rock could be piled in the corner for removal by the tractor.
  - The channel to the east of the pool runs from the column in the wall supporting the vat to the west, curves northwest as it approaches the pilaster of W1910 and then curves back to the southwest in the form of a question mark. A small channel through the wall of the pool allows the way to flow into the pool through a 3.5cm ceramic pipe. The channel is 9cm wide and 6cm deep. It is constructed somewhat crudely of plaster on top of what appears to

be a wall (visible at this time only on the northern side). This channel is one of two destinations for the water flowing out of the pipe in W1298 and then across the north wall of the southern vat. Plastering on the west face of the column and adjacent wall suggests one route down into this channel and a second route flowing north (terminus unknown).
