Hippos (Sussita) Excavations 2005 – 6th Season Daily Log + Drawing

Date:	_18 July	Area:	NEC	Manager: _	<u>Schuler</u>	
-------	----------	-------	-----	------------	----------------	--

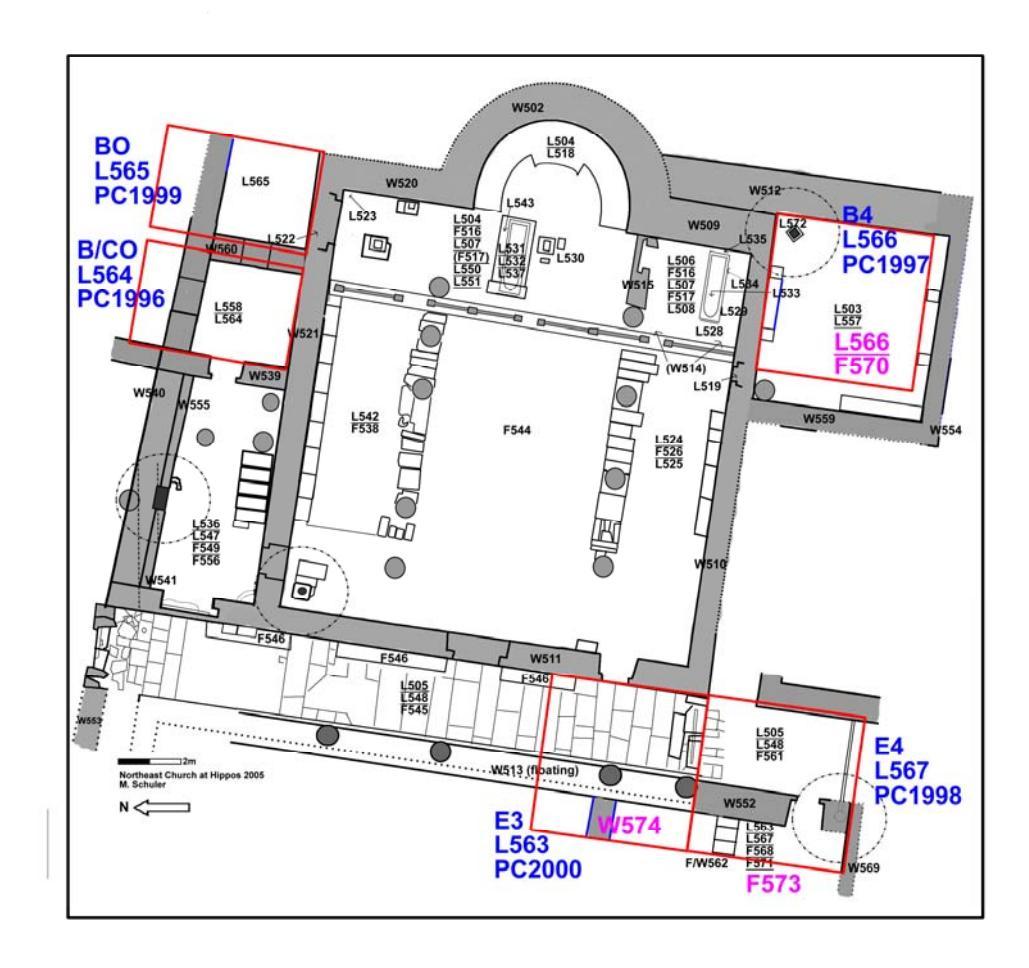
Daily Drawing

Squares	B0	B/C0	B4	E4	E3			
•		1504	1500	1507	1.500			
Loci	L565	L564	L566	L567	L563			
Baskets	1999	1996	1997	1998	2000			
Walls	W510, W513, W520, W560, W562 (formerly F562), W569							
Floors	F570, F568, F571, F573
