Hippos (Sussita) Excavations 2013 – 14th Season

Daily Log + Drawing

Date: 23 July 2013 Area: NIP Manager: Schuler

Squares	DQ39			
Loci	2126			
Baskets	3175			
Walls 1298, 1915, 1917,				
Floors

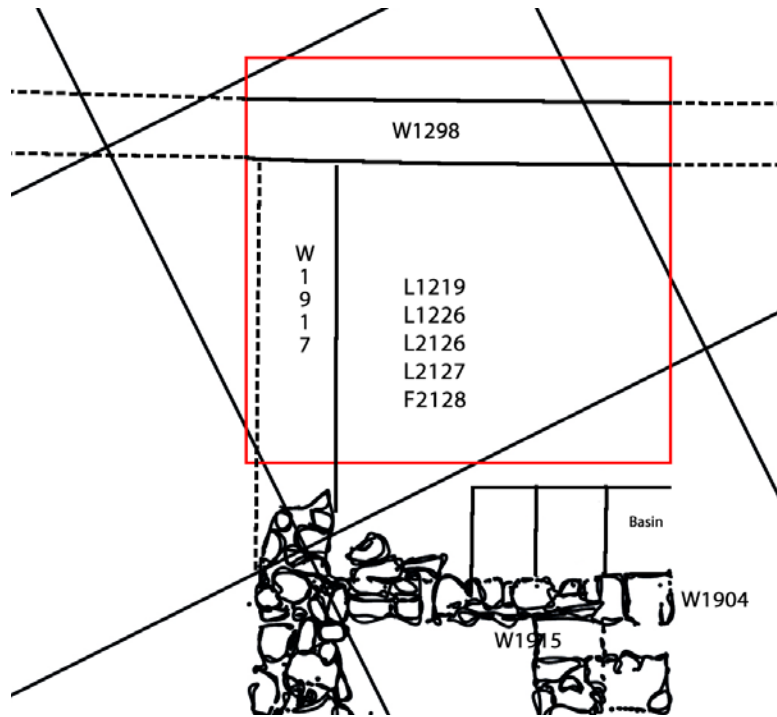
- a. Goal = to identify the SE corner of the HTyche
- b. Basket = 3175
- c. Starting elevation = 131.93 (average), 132.62 (top of W1298)
- d. Ending elevation = 131.54
- e. Soil = horizon B
- f. Heavy fill but with fewer shards
- g. Does not appear that south wall (W1915) continues into the square
- h. Discovered a plastered basin (intrusion) in the southwest corner of the square. The basin curves to a flat bottom and continues to the south into the balk.
- i. The basin is preserved to a depth of 90 cm next to the wall
- j. It is 41 cm east to west and more than 65 cm north to south
- k. It is preserved to a height of 26 cm to the north
- l. Will cut square in half tomorrow.
