## Hippos (Sussita) 2016 – 17<sup>th</sup> Season Daily Log and Drawing

Date: 18 July 2016\_\_\_\_\_ Area: NIP Manager: Schuler

Squares	DP45	DO45	DN46	DN45	
Loci	2147	2147	2160	2159	
Baskets	3467	3468	3469	4370	
Walls					
Floors

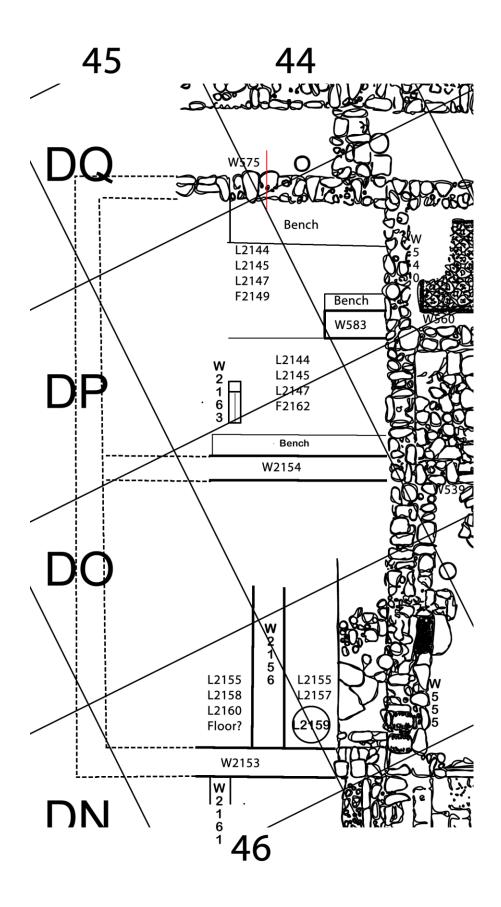
- a. Goal = discover form and function of building north of the NEC
- b. Basket = none
- c. Starting elevation = 131.31
- d. Ending elevation = 131.10
- e. Soil = tractor fill
- f. Comments
  - i. We opened the 2 meter balk between the east and west sections.
