Hippos (Sussita) Excavations 2005 – 6th Season Daily Log + Drawing

Date: ___5 July___ Area: ___NEC___ Manager: ___Schuler___

Squares	B4	D0			
Loci	L503	F547			
Baskets	1966	1965			
Walls	W540, W510, W512				
Floors	F547

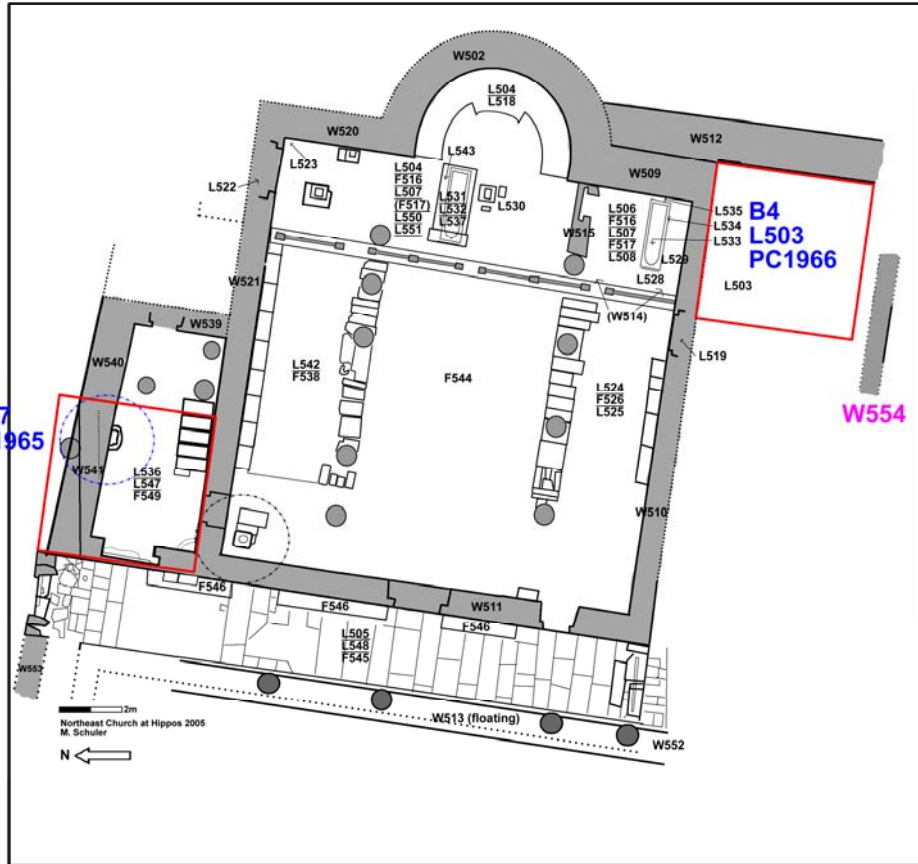
Daily Drawing

- Continued work in Square D0
 - Starting elevation = 130.58
 - Ending elevation = 130.42
 - Soil is Horizon A
 - Cleaned the installation in the southwest corner of the north lateral chamber. It was plastered and collected water (from the roof) for the cistern. Water was collected in a bowl and then channeled through the wall and flowed down a plastered surface into the cistern. Outside dimensions of the basin are 49 x 49. Inside dimensions are 34 cm (E/W) and 37 cm (N/S). The channel through the wall is approximately 15 cm wide and 10 cm high.

- Installation next to the north wall is also a collection basin for a cistern. The eastern half is plastered and seems more natural as such a collection basin. The western half appears to be destruction fill. What appears to be a corner sits above the eastern wall of the cistern. Significant destruction fill remains.

- The steps in the north lateral chamber rise an average of 20cm per step. If the steps continued to W539, they would be at a height of 2m, sufficient to reach a second story. Evidence of supporting structure for stairs east of W539 will be significant.
